Report No. FAA RD-79-58

AN INVESTIGATION INTO THE NOISE INTERFERENCE PROBLEMS AT LOGAN AIRPORT, BOSTON

April 1979

**Final Report**

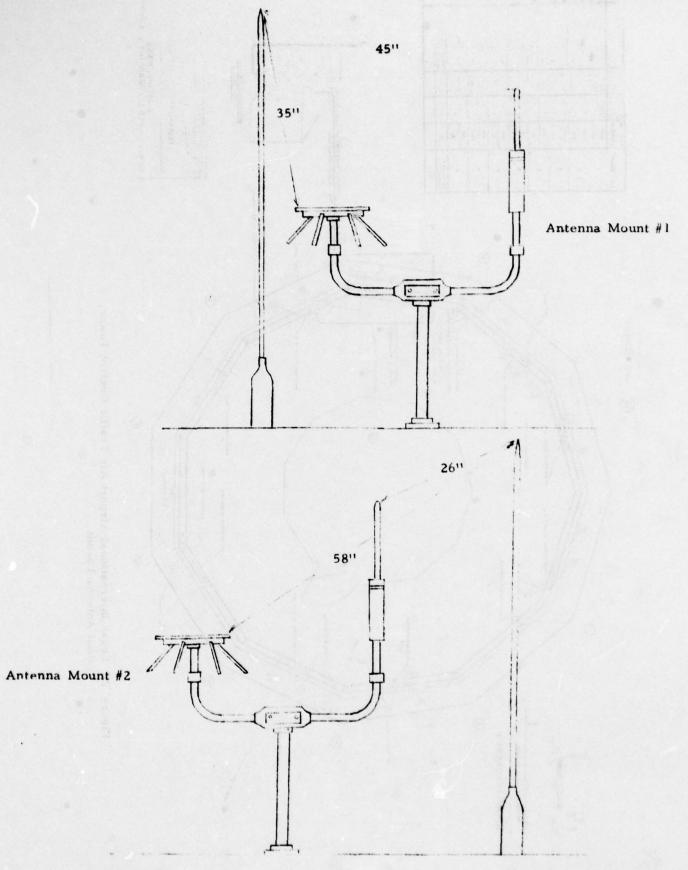
Figure 3a. Configurations of Antenna Mounts and Lightning Rods

The layout of the antennas and lightning rods is shown in Figure 2. Figures 3a-3c show the approximate positions of some of the antennas relative to the air terminals and the approximate distances to the probable corona source at the tip of the lightning rod. Antenna mount number six shows a VIIF antenna only 18 1/2 inches from a corona source, and other antennas are spaced not too much further away from other lightning rods. The nearest UIIF antenna is some 35 inches away.

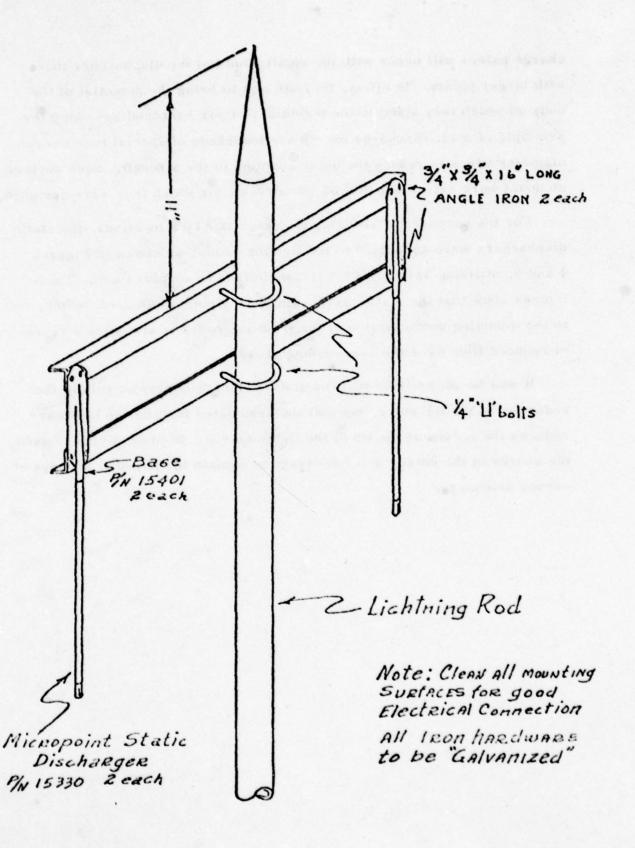
Figure 4. Installation of Static Discharger on ATCT Lightning Rod

It will be shown later that the static discharges play no role in the reduction of the RF noise, but that the associated installation hardware reduces the corona at the tip of the lightning rod. In order to understand the source of the noise, it is necessary to explain the physical process of corona discharge.

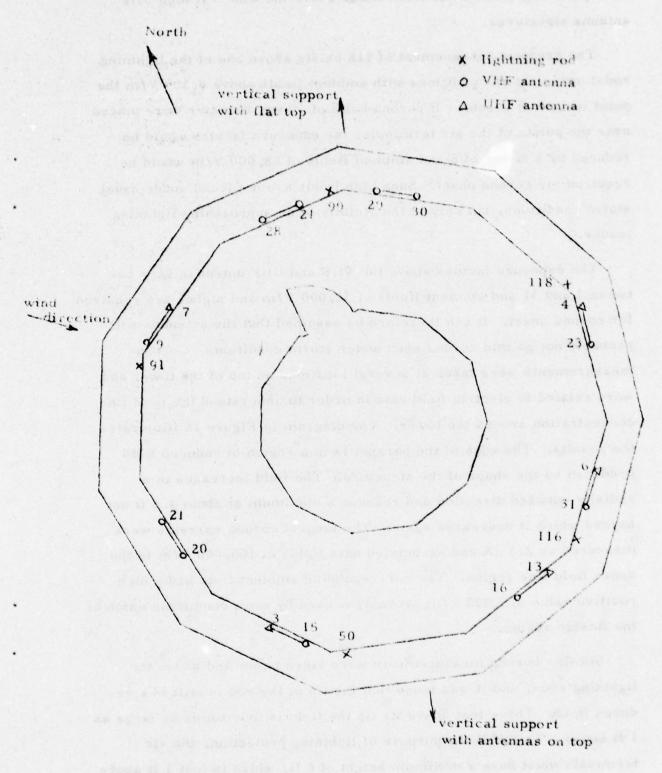
These results are shown in Figure 15. The exposure factors are largest for high rods with small radius of curvature well separated from other rods and field reducing structural features. The highest electric fields are above the sharp points of the 6 ft air terminals. The fields are significantly lower above the blunt, 1" diameter VHF antennas which are

Figure 15. Exposure factors versus ground on top of the lightning rods and ViiF antennas on the Logan International Airport air traffic control tower.

The greatest enhancement of 118 exists above one of the lightning rods; under storm conditions with ambient fields above 8,500 V/m the point will be in corona. If corona balls of 10 cm diameter were placed over the points of the air terminals, the exposure factors would be reduced by a factor of 8 and ambient fields of 68,000 V/m would be required for corona onset. Such high fields are not found under usual storm conditions, but only in the vicinity of an approaching lightning leader.

The exposure factors above the VHF and UHF antennas vary between 3 and 31 and ambient fields of 32,000 V/m and higher are required for corona onset. It can therefore be assumed that the antennas will probably not go into corona even under storm conditions. Corona measurements were taken at several locations on top of the tower and were related to electric field data in order to understand the field line concentration around the tower. The diagram in Figure 16 illustrates the results. The edge of the parapet is in a region of reduced field produced by the shape of the structure. The field increases in a radially outward direction and reaches a maximum at about 4.5 ft out beyond which it decreases again. The largest corona currents were measured as 2.3 µA and associated with fields of 100,000 V/m in the dense field line region. The corresponding ambient field had a high positive value of 1,200 V/m probably caused by snow conditions north of the Boston region.

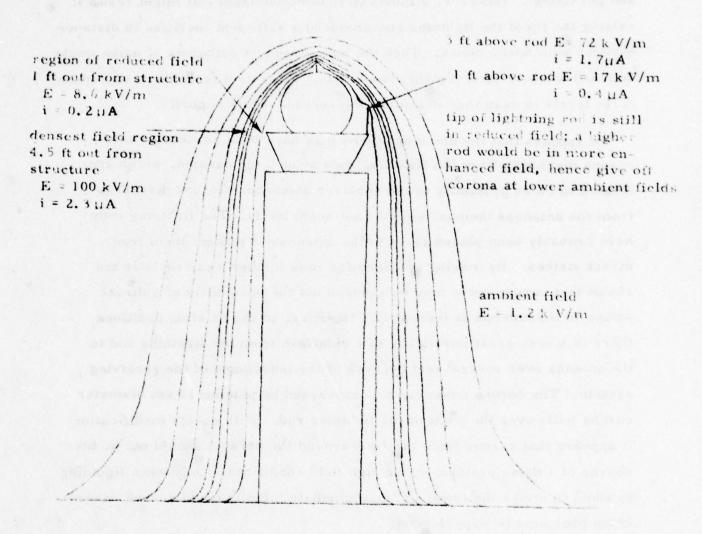
Similar corona measurements were taken below and above the lightning rods, and it was found that the tip of the rod is still in a reduced field. Three feet above its tip the field is four times as large as 1 ft above. To fulfill the purpose of lightning protection, the air terminals must have a minimum height of 6 ft, which is just 1 ft above

Figure 16. Equipotential lines around structure go through enhanced density 4.5 ft out from structure as determined from corona current (i) measurements.

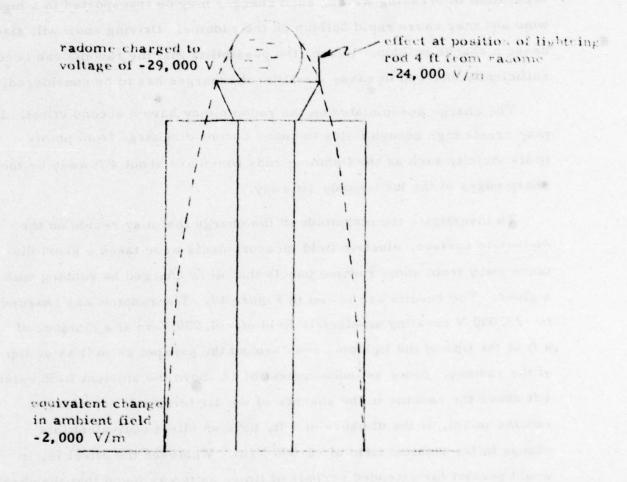
The charge accumulated on the radome may have a second effect. It may create high enough fields to cause corona discharge from points in its vicinity such as the lightning rods which are about 4 ft away or the sharp edges of the ladder only lft away.

Figure 17. Effect of radouse charge on electric field. (distorted scale)

to the rods, hence their effect is reduced. To understand this problem would require involved computations and additional measurements. At the location of the ladder about Ift away from the radome the fields, due to the radome charge, are even much higher of the order of -95,000 V/m, and at the ladder support and the bottom of the highest lightning rou the field might be so high that there exists continuous corona discharge. Furthermore, the potential of the radome could reach values much higher than those we caused with a fur glove.

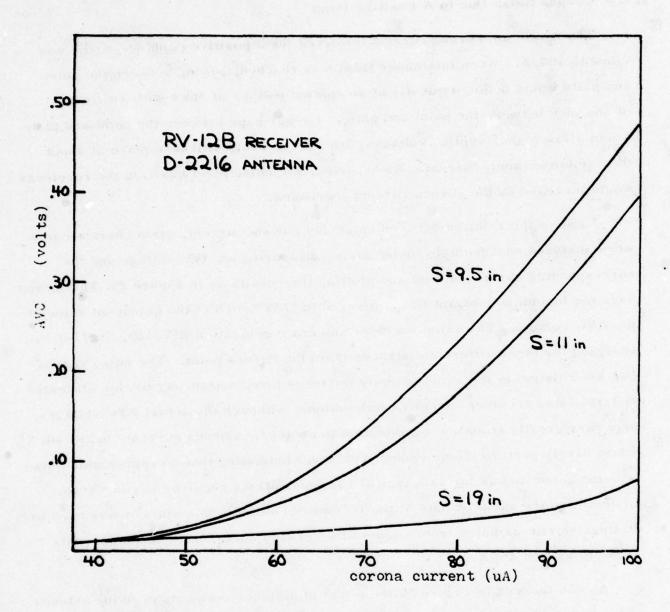
To show the relation between noise and corona current, strip chart records were analyzed on a point-by-point basis, measuring an AVC voltage and the corresponding corona current and plotting the results as in Figure 25. This graph does not include a constant D. C. offset of 0.372V which is the quiescent value of the AVC voltage. The same receiver-antenna combination (RV-12B, D-2216) was analyzed for three different distances from the corona point. The noise versus current relation is the same not only for these three distances, but for all tested distances and receiver-antenna combinations, although the actual AVC voltages may vary greatly from one combination to another. Corona currents below  $40\mu$  A would barely perturb the quiescent AVC level indicating that no appreciable noise is being generated as far as a typical communications receiver is concerned. Listening to the audio outputs of the receivers confirms this since it was hard to distinguish corona noise from ambient background noise until corona currents began to exceed  $25\mu$ A.

Figure 25. Noise level vs. corona current for a positive point at three distances

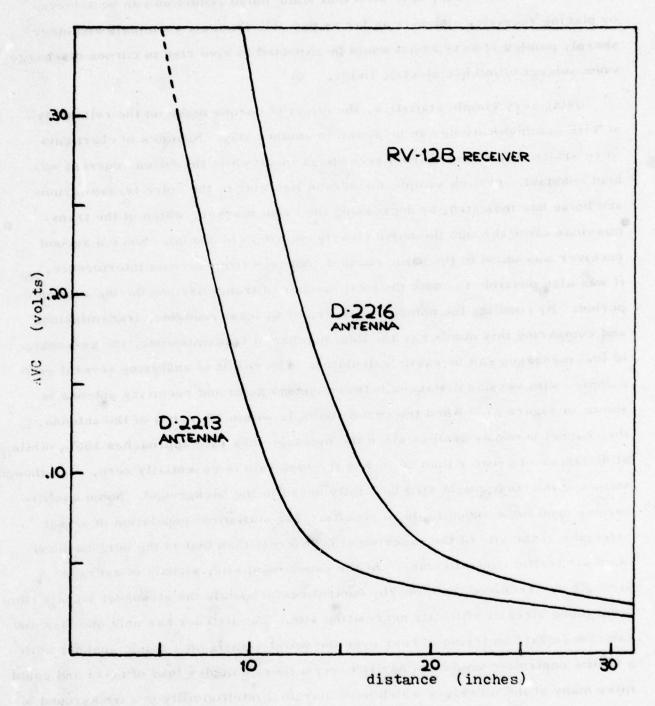
As can be seen in Figure 26, the effect of distance between receiving antenna and corona point is important in determining the resultant noise level at the receiver. Here again, the AVC voltage is taken as the measure of noise level and indicates that serious noise interference is to be expected whenever a positive point discharge occurs within 24 inches of a receiving antenna. The curves shown in this figure were derived from recorded data on a "worst case" basis, i.e., the maximum noise-induced AVC voltage was used to represent the noise level at each distance. Some data was obtained at distances greater than 50 inches, but it was difficult to obtain reliable measurements at these distances since the noise

Figure 26. Noise level vs. distance using two different antennas and a positive point discharge

level was so low. Thus, it is seen that some noise reduction can be achieved by placing receiving antennas as far as possible from air terminals and other sharply pointed objects which would be expected to give rise to corona discharge when subject to intense electric fields.

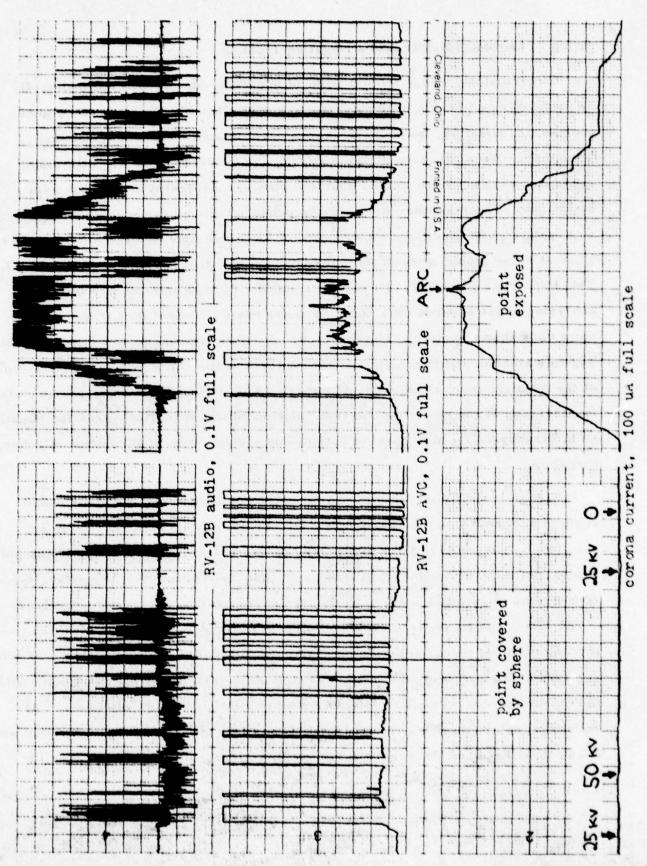
It is obvious that it should be more effective to eliminate corona discharge than to attempt to reduce the noise effects which must be present whenever the discharge occurs. A well known result of the theory of electrostatic fields has been discussed previously (Sec. 3), i, c., the electric field will be concentrated in the neighborhood of any sharp, electrically conducting object. This is the reason that electrical discharge (corona) will be initiated at the sharpest point or irregularity on a conducting surface. Consequently, if a conducting sphere were placed so as to cover the point of the corona apparatus, the discharge would be suppressed. Confirmation of this is seen in the pair of chart records shown in Figure 28. One recording was made immediately after the other with no change except to cover the corona point with a brass sphere of one inch diameter. The air gap space between the plate and sphere was the same as it was between the plate and point (1,6 in.) and the distance from the corona apparatus to the antenna (D-2213) was #5 inches. While the point was exposed, corona discharge took place at increasing currents until arcing occurred at 94 \$\mu A\$ with an applied voltage of 25kV. When the sphere was used to cover the point, arcing did not occur, even at potentials of 50kV and no corona current greater then 2µA could have existed as is indicated by the zero-line trace in the corona current section of the chart record. Voice transmissions occurred during both tests and are clearly indicated by the tall, off-scale excursions in the AVC trace.

Figure 28. Noise reduction by placing a sphere over the corona point

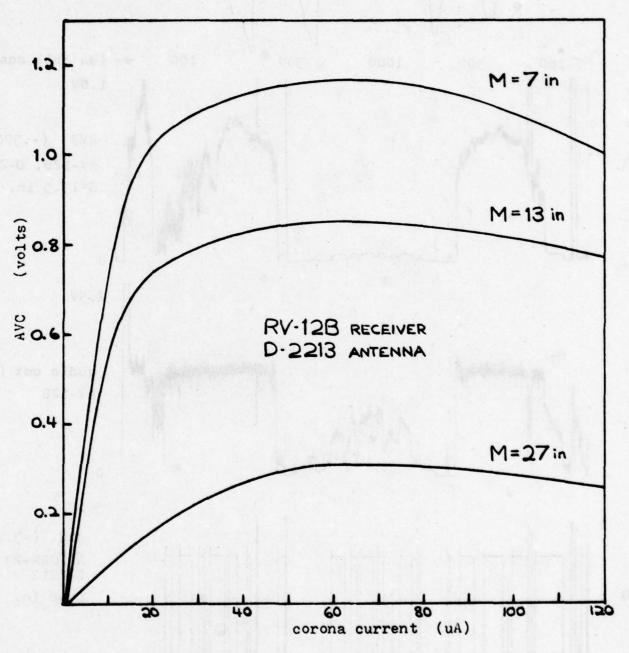
Figure 29. Noise level vs. corona current for a negative point at three distances

increased directly (but not linearly, e. g., Figure 25) as the corona current increased. In the case of negative point discharge (Figure 29), the current/noise relationship is more complicated. Noise levels reach a maximum in the neighborhood of 60µA and decrease slightly as current increases to 100µA. At a current above 100µA, a sudden decrease or cu -off of corona noise occurs in the negative point case. The precise current at which this cut-off takes place varied from one test to another, but was usually found between 100µA and 150µA. As negative point discharge currents increased from 5µA to 10µA, a sudden peak was intermittently found in the noise level. This threshold peak would sometimes produce greater noise than that due to currents of 50µA to 100µA. The noise cut-off and threshold peak phenomena are not shown in Figure 29 (which presents the average result of many tests) but can be clearly seen in trace B of Figure 30 as well as many of the other chart recordings. Because of the threshold peaks and noise cut-off phenomena, there is no simple relation between corona currents and resultant noise levels.

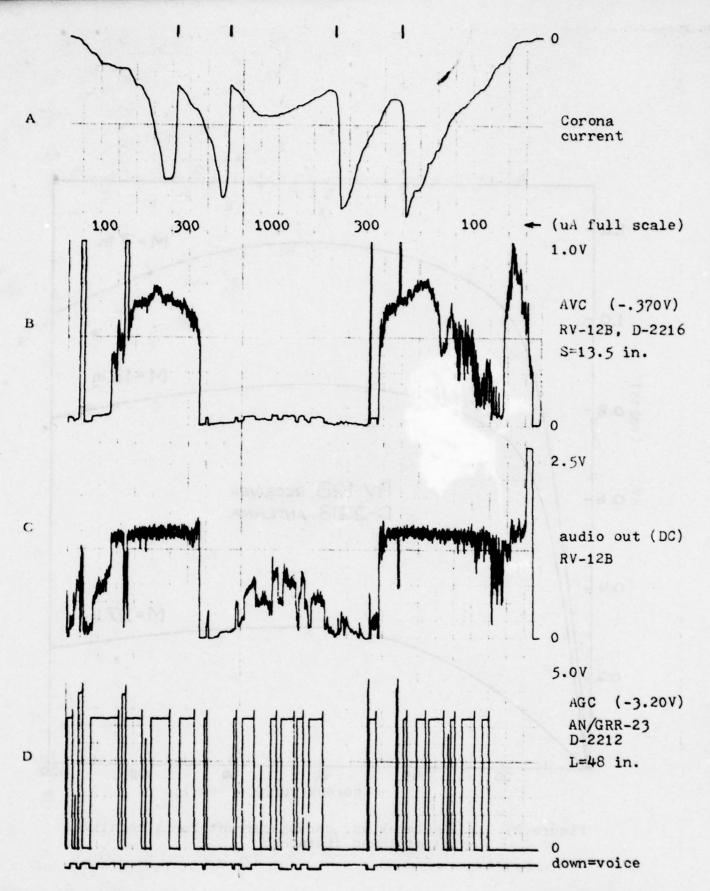
Figure 30. Corona noise from a negative point and voice blank-out due to noise (6-23-78)

Also seen in the AVC trace of Figure 30 is the occurrence of a very strong peak in corona noise which occurred while the corona current was being adjusted from zero to  $10\mu$ A. This noise, which occurs in the threshold of corona discharge, is an erratic but frequently occurring phenomena that can give rise to noise levels that are greater than those associated with much higher corona currents. Moreover, the threshold noise sounds much different than the noise produced by the higher currents, having a whistling or howling character instead of the hissing sound which accompanies corona noise produced by higher currents. The threshold peak is very sharply defined as a function of corona current and usually reaches its maximum when the current is near  $4\mu$ A. If the corona current is not increased very slowly the threshold peak can be easily missed. In Figure 31 the chart recorder was operated at a speed of 5 mm/sec rather than the usual 0.5 mm/sec to obtain

to the highest AVC levels recorded in Figure 38. The presence of the threshold peaks in many of the audio output traces is an indication of the presence of this low-current phenomena, but cannot be taken as a measure of its strength in competition with incoming voice signals. Rather, the audio peaks indicate the failure of the AVC circuit to function optimally when the noise level is low. In other recordings, however, the threshold noise peak can give rise to the maximum perturbation in AVC level as was seen in Figure 30.

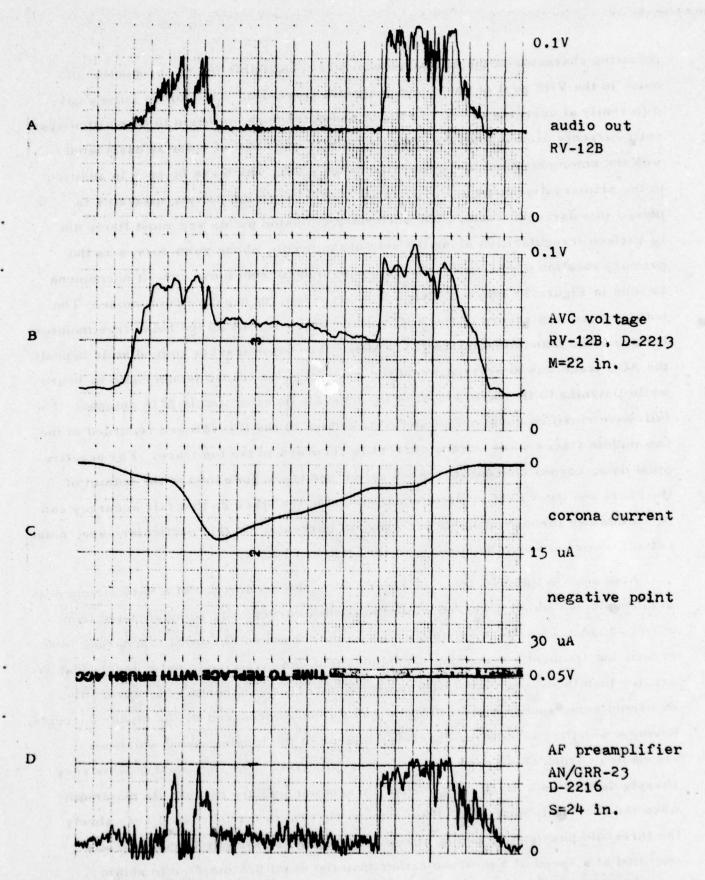
Figure 31. Correlation of threshold peaks with AVC voltage, chart speed = 5 mm/s (5-31-78)

better time resolution of the correlation between the AVC and peak audio voltages in the threshold noise region. The phenomenon was not confined to any one combination of receiver, antenna, and corona point apparatus and therefore seems to be a consequence of low current discharges rather than an artifice of the initial action of a receiver's AVC circuitry. Corona discharge pulses have greater amplitudes at low current levels and this may be related to the exceptionally high noise level which is produced occasionally between 0-10 µA. Wind speed and other local changing conditions could be the reason why the phenomena is not always present.

Most of the tests were performed on the RV-12B receiver because of the unit's ability to monitor smaller increments of signal strength at the AVC output. Even though the AN/GRR-23 receiver had a more sophisticated noise suppression system, the final noise received from corona was found to be the same in both systems and would lead to the same amount of trouble for a controller communicating with an aircraft (see Figure 31).

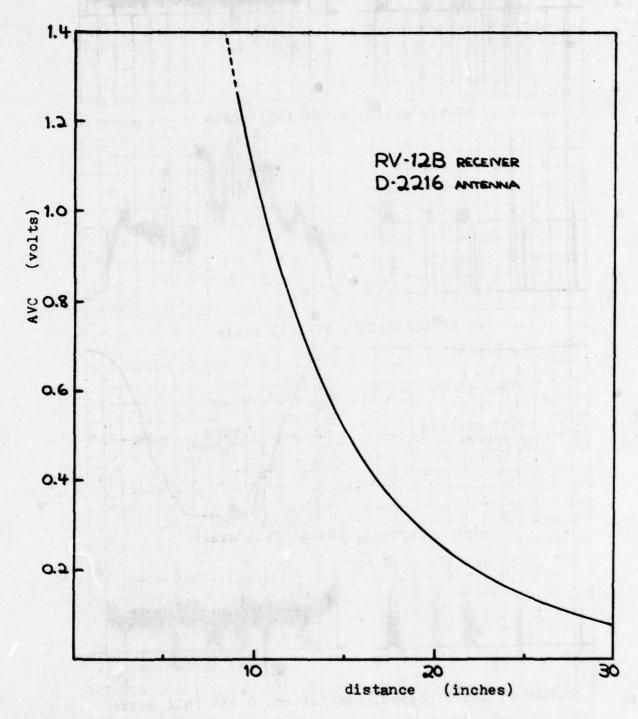
Figure 32. Noise level vs. distance for a negative point discharge

As was seen before with positive point data, the intensity of noise from a negative point varies inversely with the distance between the corona point and receiving antenna (D-2216) as shown in Figure 32. This graph was prepared by finding the maximum AVC voltage for currents between 20 and 100 µA for each of several distances between corona point and antenna. The AVC voltage for the threshold noise peak was ignored because of its erratic character, but threshold noise also varies with distance in much the same manner. As with the noise from positive point discharges, the noise level is very low when the distance between point and antenna is greater than 50 inches. Likewise, placing a 1 inch diameter sphere on top of the corona point inhibits the discharge process so that no noise is produced as seen in Figure 33. In this record, the two top traces are from the RV-12B receiver and show its audio output and AVC voltage. The bottom trace is a record of the audio preamplifier output from the AN/GRR-23 receiver which was operated with the squelch circuit turned on. The corona point was at a distance of 12 inches from the D-2213 antenna which was feeding the RV-12B and 35 inches from the D-2216 antenna which was connected to the AN/GRR-23.

Noise from any source will decrease in intensity as the distance between the source and receiving antenna is increased. The manner in which this decrease takes place (-1/d') is shown by Figures 26 and 32 which are drawn from positive point and negative point data, respectively. The noise-induced AVC voltage decreases by 50% (from 0.30V to 0.15V) as the distance between a positive point discharge and antenna D-2216 increases from 10 inches to 15 inches (Figure 26). Likewise, for a negative point (Figure 32), a 50 % decrease (from 1.0V to 0.5V) is seen when the distance increases from 10 inches to 15 inches. This is the 1/d<sup>2</sup> relationship.

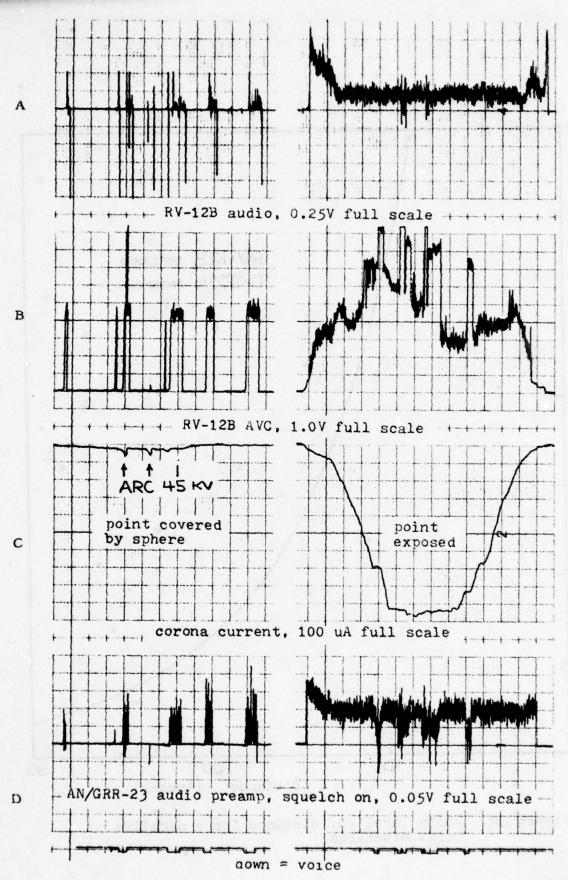
Figure 33. Noise reduction by placing a sphere over the corona point

be required to initiate the discharge when the radius of curvature of the point is increased. These predictions are clearly shown to be true by Figure 28 (for a negative point) and Figure 33 (for a positive point). In both of these figures two tests are shown side-by-side. Trace C in both figures shows that the discharge is suppressed by placing a metal sphere with radius 0, 5 inches (1.27 cm) over the needle point which had previously produced discharge currents of 100 µA. Since the discharge is suppressed, the noise associated with it is also reduced as shown by the recorded AVC voltage, trace B in both figures. The field strength during these tests went as high as 10 V/m (50kV across a 2 inch gap) without initiating discharge at the sphere. (Some corona discharge was produced at other less-rounded points on the high voltage equipment.)

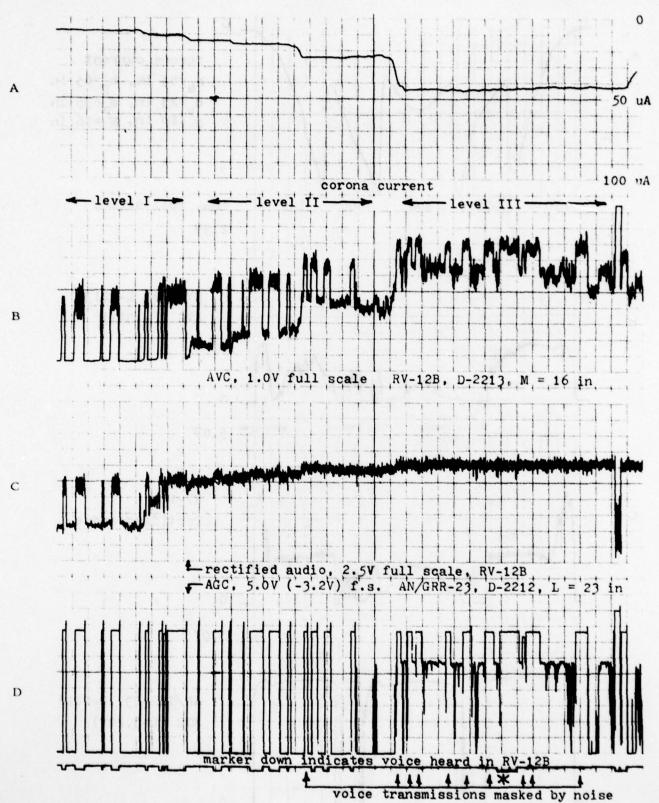
Figure 39. Masking of voice communications by noise from a negative point discharge and examples of noise levels I, II, and III

Noise interference from a negative point discharge was studied as a function of corona current by keeping the current adjusted to a constant value for minutes at a time and listening to the combined noise and voice message in the audio output of the RV-12B receiver while the AN/GRR-23 acted to indicate the presence of voice which could not be audibly detected. Current's from 8 to 10µA produced level I noise which could be heard as a background to an otherwise clear message and produced an increase in AVC level of only 0.05V, as seen at the left side of Figure 39. In the middle of this figure, currents range from 10 to 25 µA and produce level II noise which caused great difficulty in understanding the content of any message even though the presence of a voice was heard in every case but one. At the right, currents are between 42 and 45 µA and produce level III noise which blanked out communications almost completely and even elevated the AGC baseline of the usually noisefree AN/GRR-23 and D-2212 receiver-antenna combination. The event marker was depressed whenever voice was heard, even if a message could not be clearly understood. In one case, which is marked by an asterisk (\*) in the level III period, the listener became confused while trying to indicate even the most marginal presence of a voice. While straining to hear anything at all, the voice marker was kept down for a few seconds after the signal itself had ceased. In the middle of the transmission the marker was released as the noise momentarily covered the voice of pletely. At the extreme right, an exceptionally strong signal broke through the noise quite clearly.

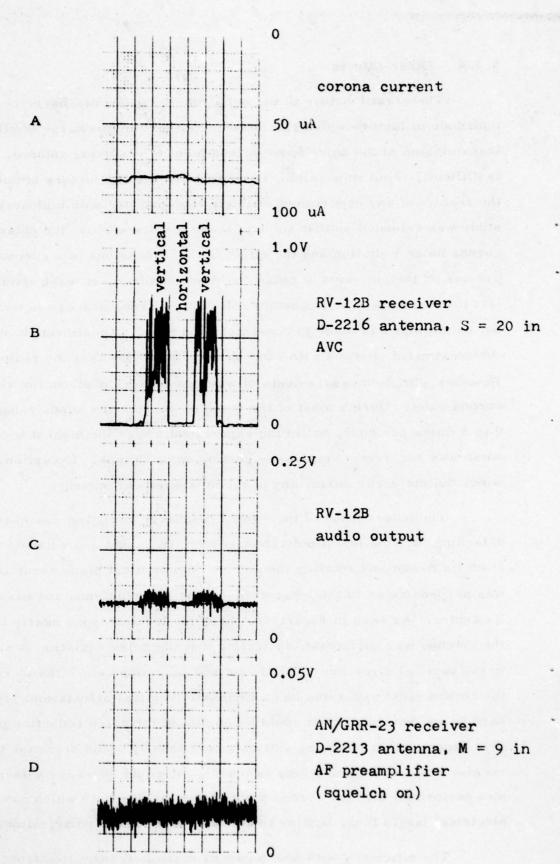
Figure 40. Polarization of radio noise from a corona discharge

The polarization of the corona discharge radiation was examined by detaching the smallest dipole antenna from its mount and rotating the antenna from its mount and rotating the antenna in a vertical plane about an axis which was perpendicular to the longest dimension of the antenna and passed through its center. As seen in Figure 40, the noise level dropped nearly to zero when the antenna was horizontal, indicating that the noise radiation is strongly polarized in the vertical direction. This is not too surprising since the electric field of the corona point apparatus has a primarily vertical orientation. However, it is hard to see how this effect could be employed for noise reduction purposes since it is expected that mounting antennas horizontally would decrease their ability to receive voice communications as much as it would decrease noise. This experiment was performed with the corona point shown in Figure 19 which has a very short electrical length thus, leading to a small effect on the polarization.

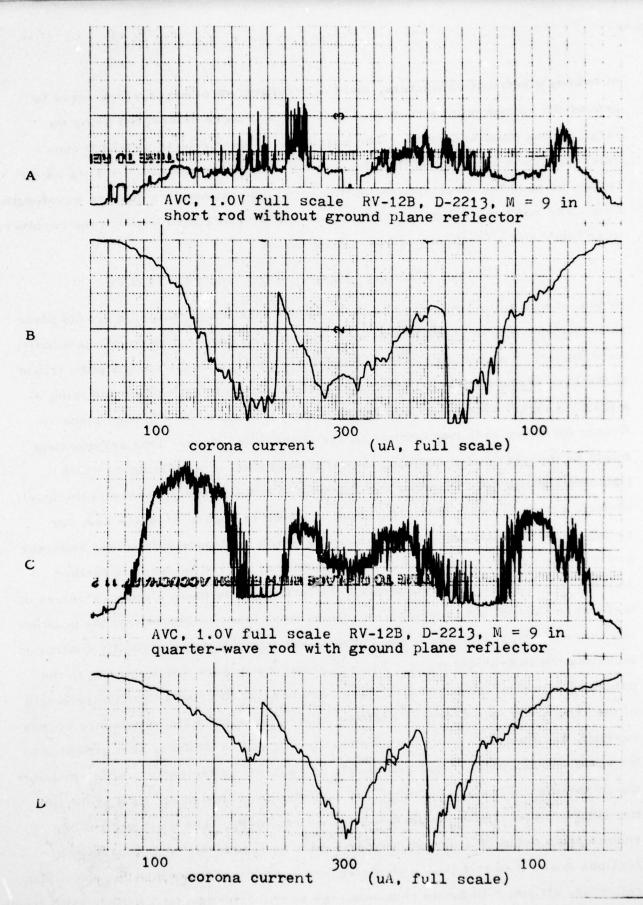
Figure 41. Comparison of different corona noise radiating geometries

Hence, it was quite simple to use the common practice of placing a ground plane reflector at the base of a quarter-wave antenna to convert it to an efficient halfwave dipole. Two pieces of steel channel were placed on the corona point tripod at the base of the rod, being arranged at right angles to each other and lying in a plane perpendicular to the rod so that they would serve as a ground plane reflector for noise radiation emitted by the corona discharge. This arrangement might be thought of as simulating the structural steel of a building on which a lightning rod has been mounted and it produced a noticeable increase in the level of noise received by the RV-12B. This is shown in Figure 41 which has, for comparison, a noise and current recording which was made without the reflector and with the ground lead attached to the middle of the rod in order to further shorten its effective radiating length. To further study these effects, a series of tests were carried out in which precautions were taken to insure that the position of every electrical element in the corona point apparatus was carefully controlled, including the instrument leads. Electrical current pulses which are due to the pulsating nature of the corona discharge are carried to ground through the length of the rod, a 100 ohm dropping resistor which allows a VTVM to measure corona current, and then back to the high voltage power supply which is also grounded to the metal corona point tripod that stands uninsulated on the earth. This simulates the grounding circuit of a lightning rod installation (although for good protection the inductance to ground should be as low as possible). The more interesting results from the series of tests are presented in Figure 42. A comparison of sections A and B of this figure shows again the effect of removing the ground plane reflector, all other elements remaining the same. The dramatic difference between

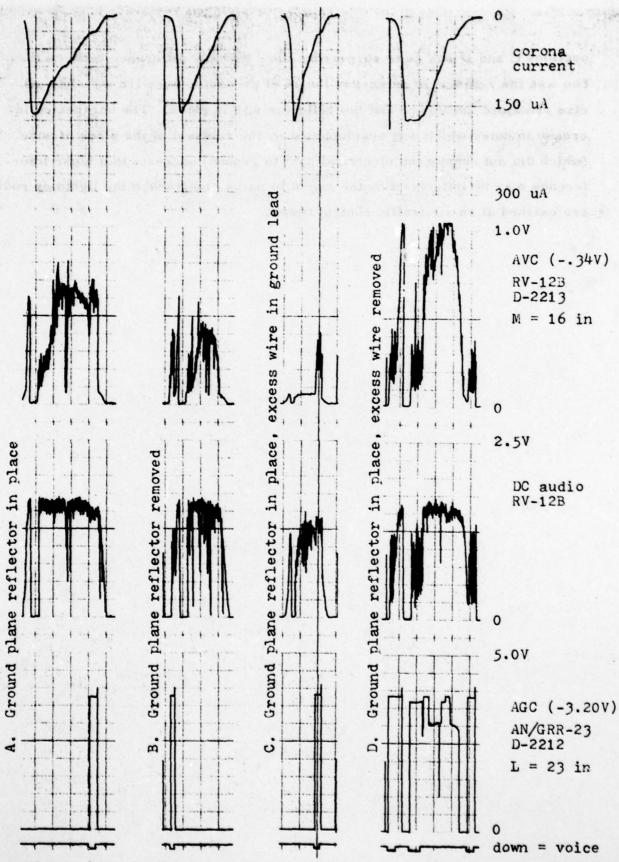
Figure 42. Radiative effects related to length of rod and placement of ground leads

sections C and D was quite surprising since the only difference between these two was the removal of an excess length of grounding wire (18 in) while all else remained unchanged and the reflector was in place. The unexpected increase in noise which was accompanied by the removal of the piece of wire (which did not change the electrical path to ground) suggests that noise interference may be influenced by the layout of paths along which the lightning rods are earthed at an air traffic control tower.

noise suppression. The data presented in Figure 42 show that the coupling of corona noise from source to receiving antenna can be modified by a factor of 10 or more when minor changes are made in the geometry of conductors which are near the corona point. At the same time, however, the data show that this aspect of the problem is exceptionally complex.
